Soil Under Pavement Plot
July 23, 2015
Bartlett Tree Research Laboratories
Charlotte NC

Overall Research Results

Sidewalk Trials

Comparison of Methods to Reduce Sidewalk Damage from Tree Roots

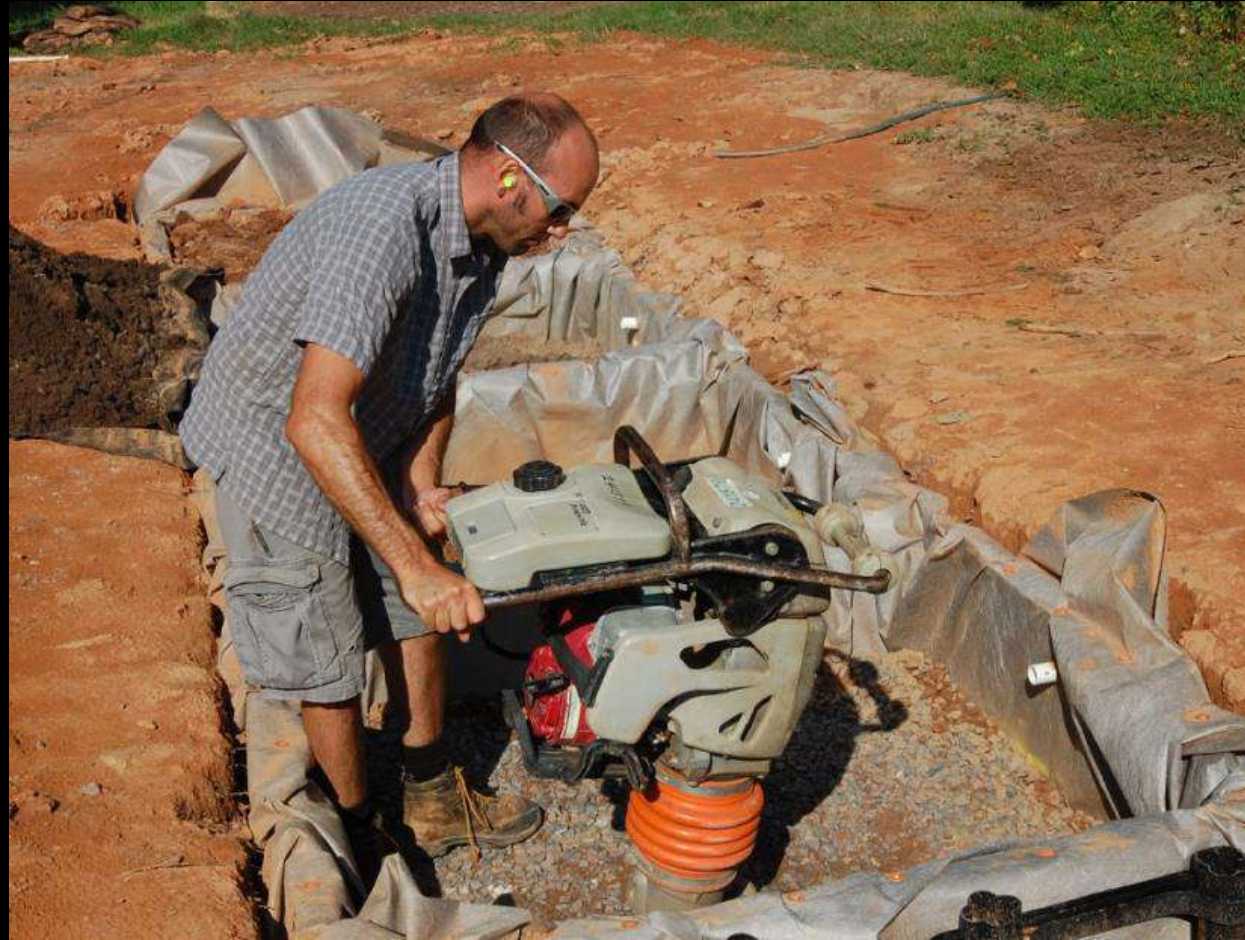
Gravel Based Structural Soils

80% gravel, 20% soil.

Compacted to 95% Proctor. Based on Cornell Structural Soil

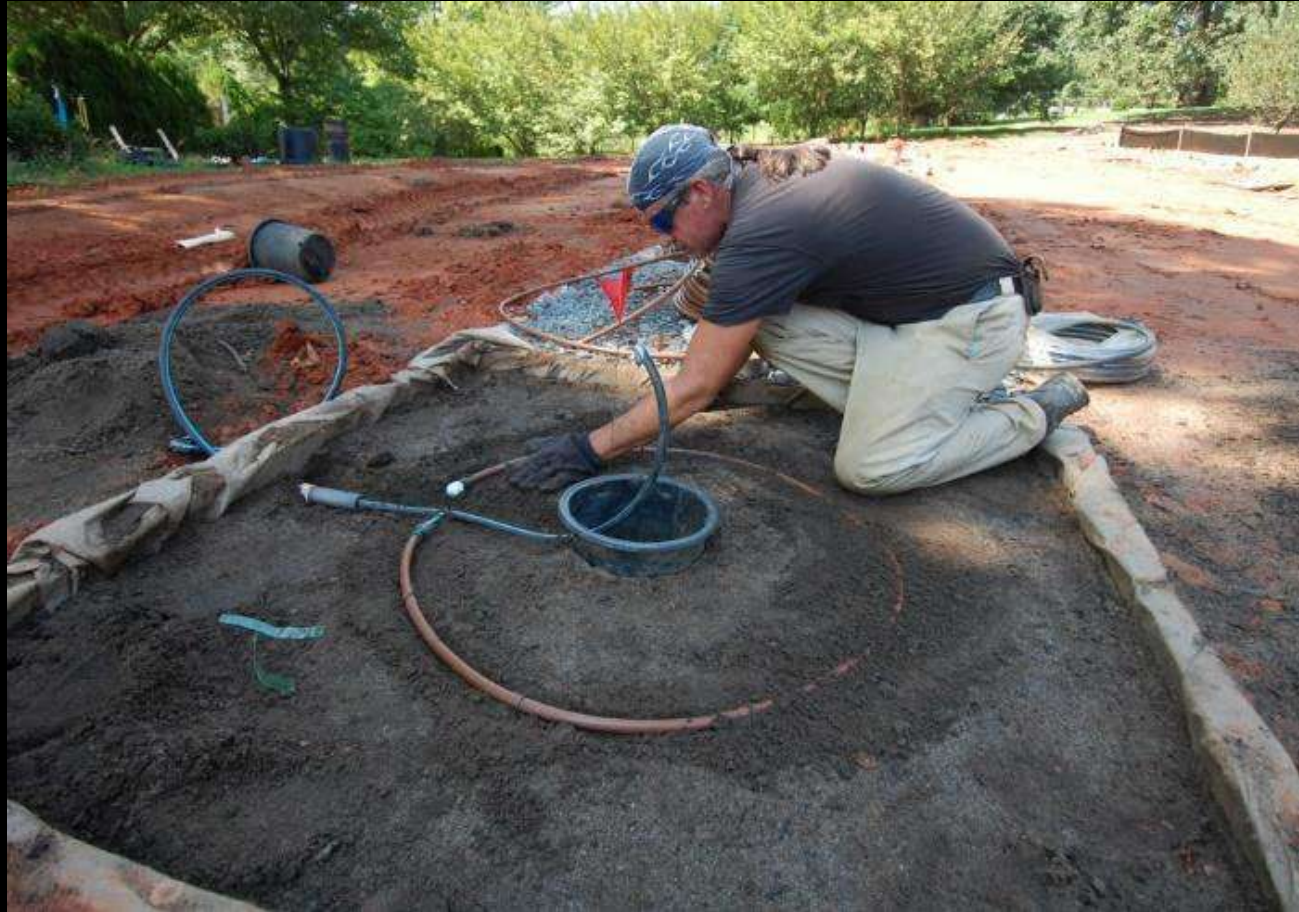
Sand Based Structural Soil

Gravel layer below and above sand, ring irrigation
Compacted to 95% Proctor

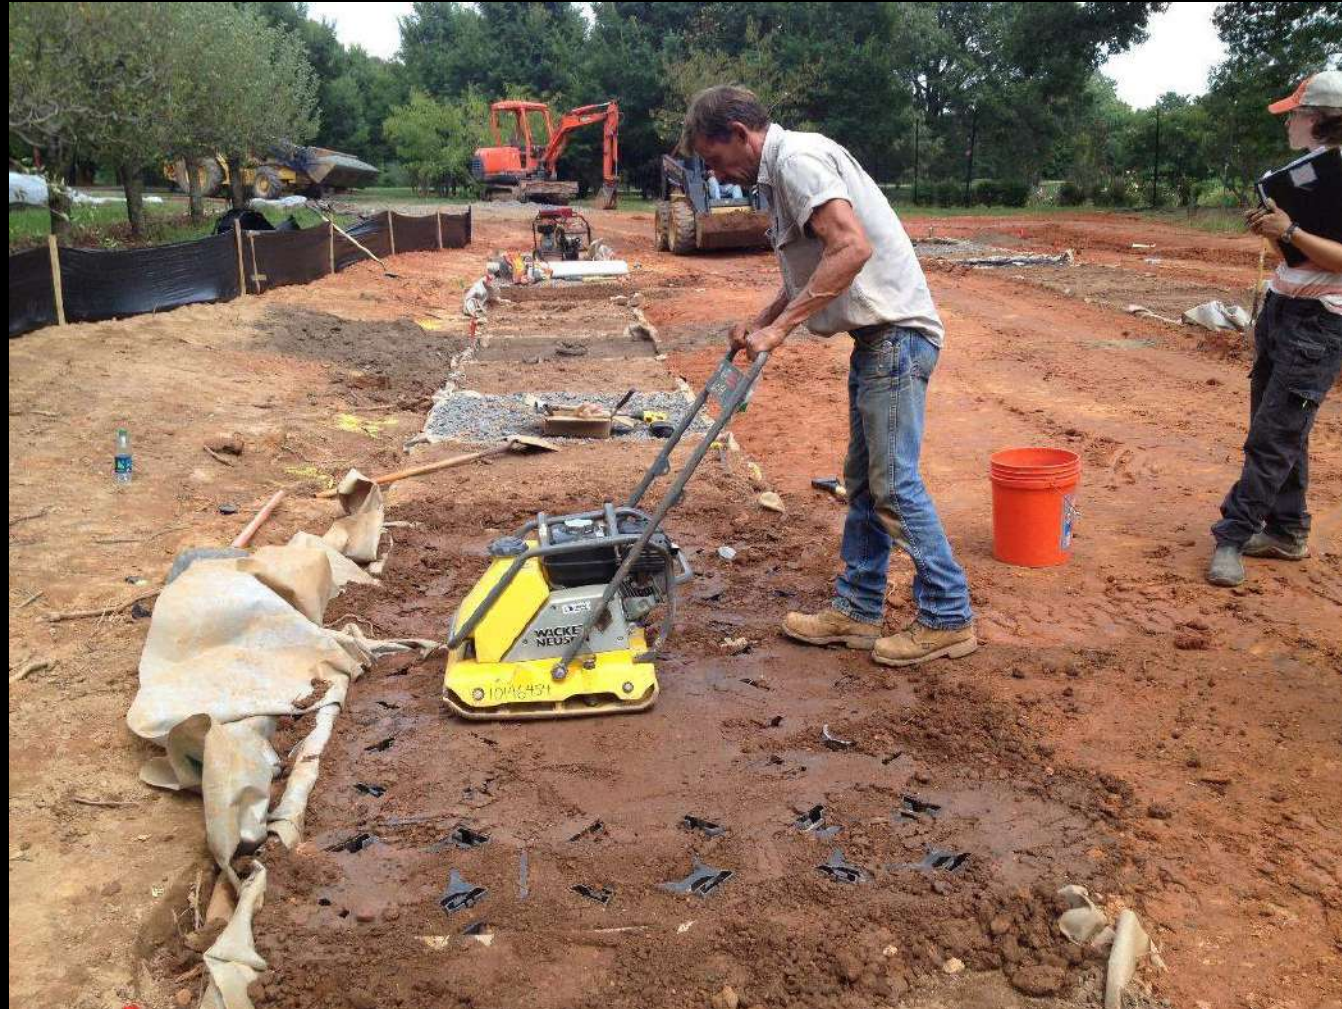
Stata Cell – vibrating to work soil into cells

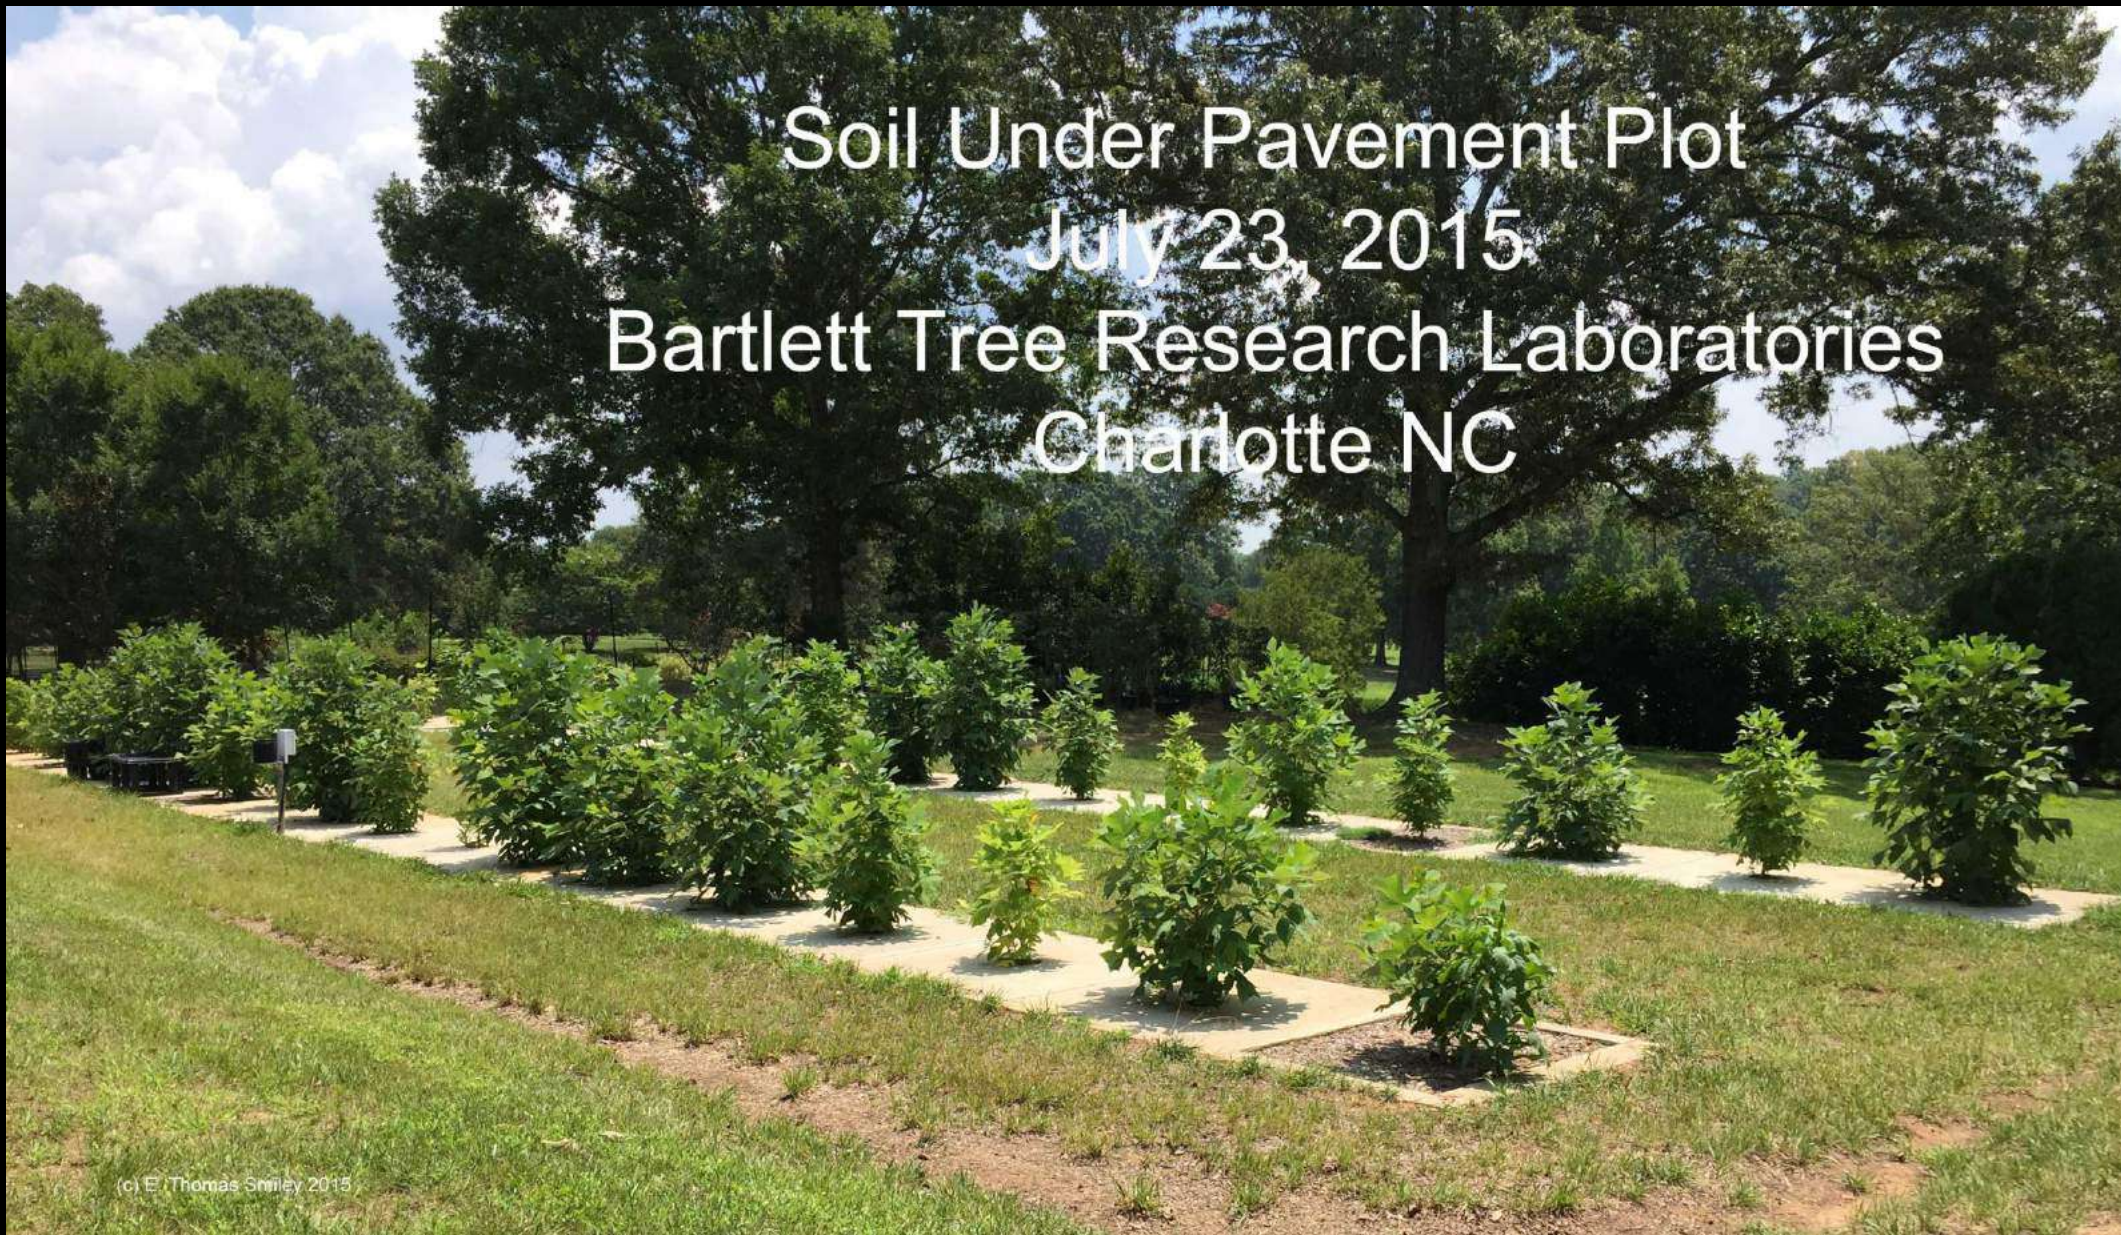
Large differences in growth during the summer of 2015. One year after planting.

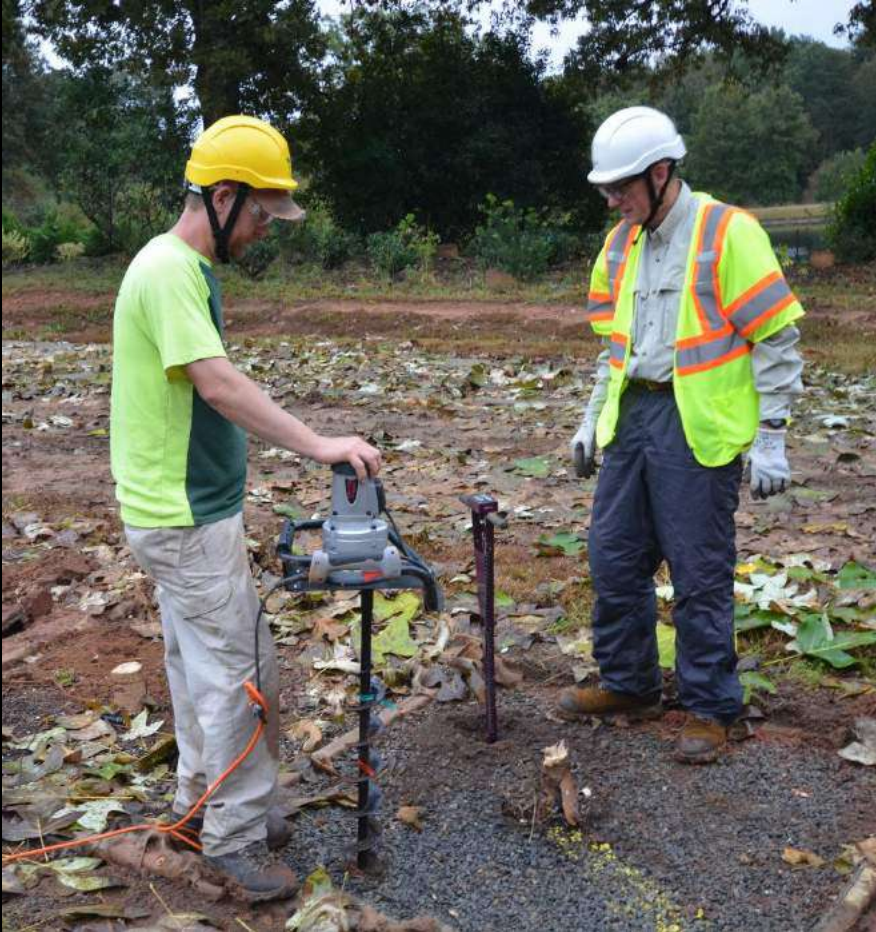
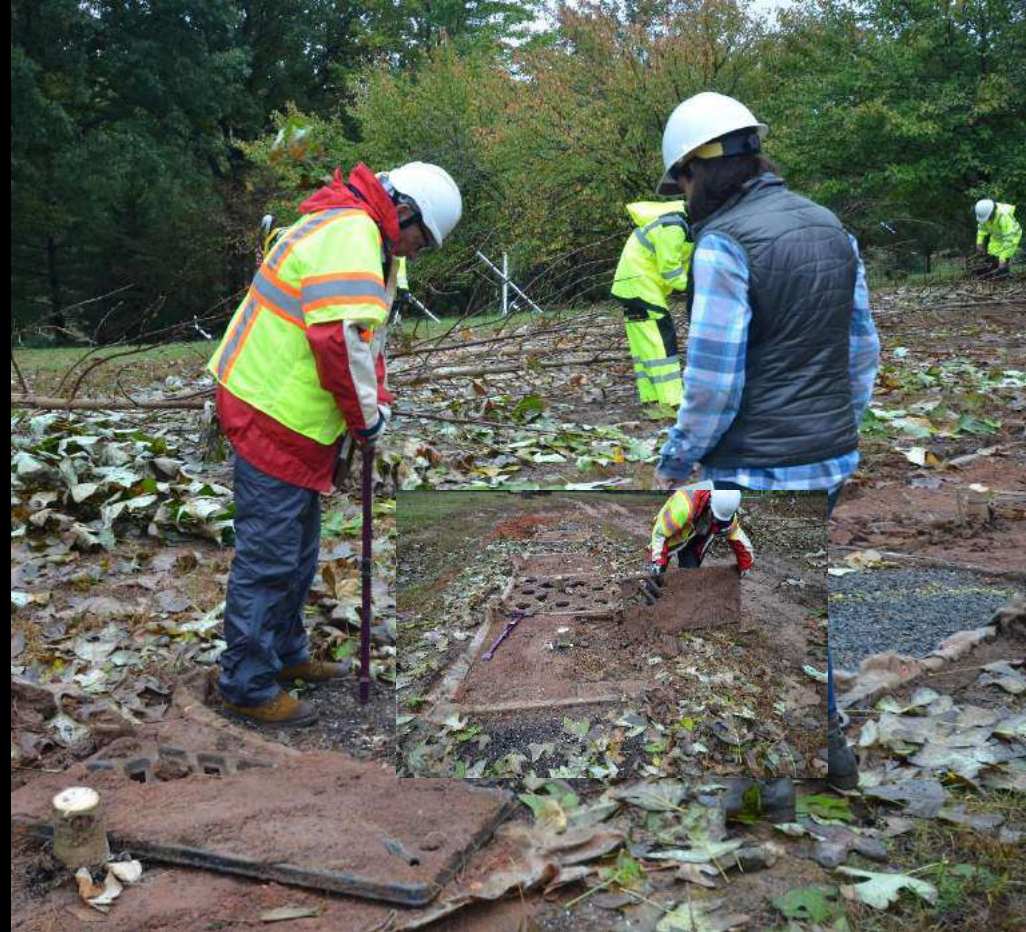
Measuring Soil Moisture at 15 cm intervals

Treatment	Surface	15cm	30 cm	45 cm
Comp Control	33***	34**	30**	20
Comp Sand	13*	15*	17*	13
Gravel St Soil	NA	NA	NA	NA
StrataCell	22**	19*	20**	20
Silva Cell	23**	23*	24**	19
Open Control	29***	23*	25**	19

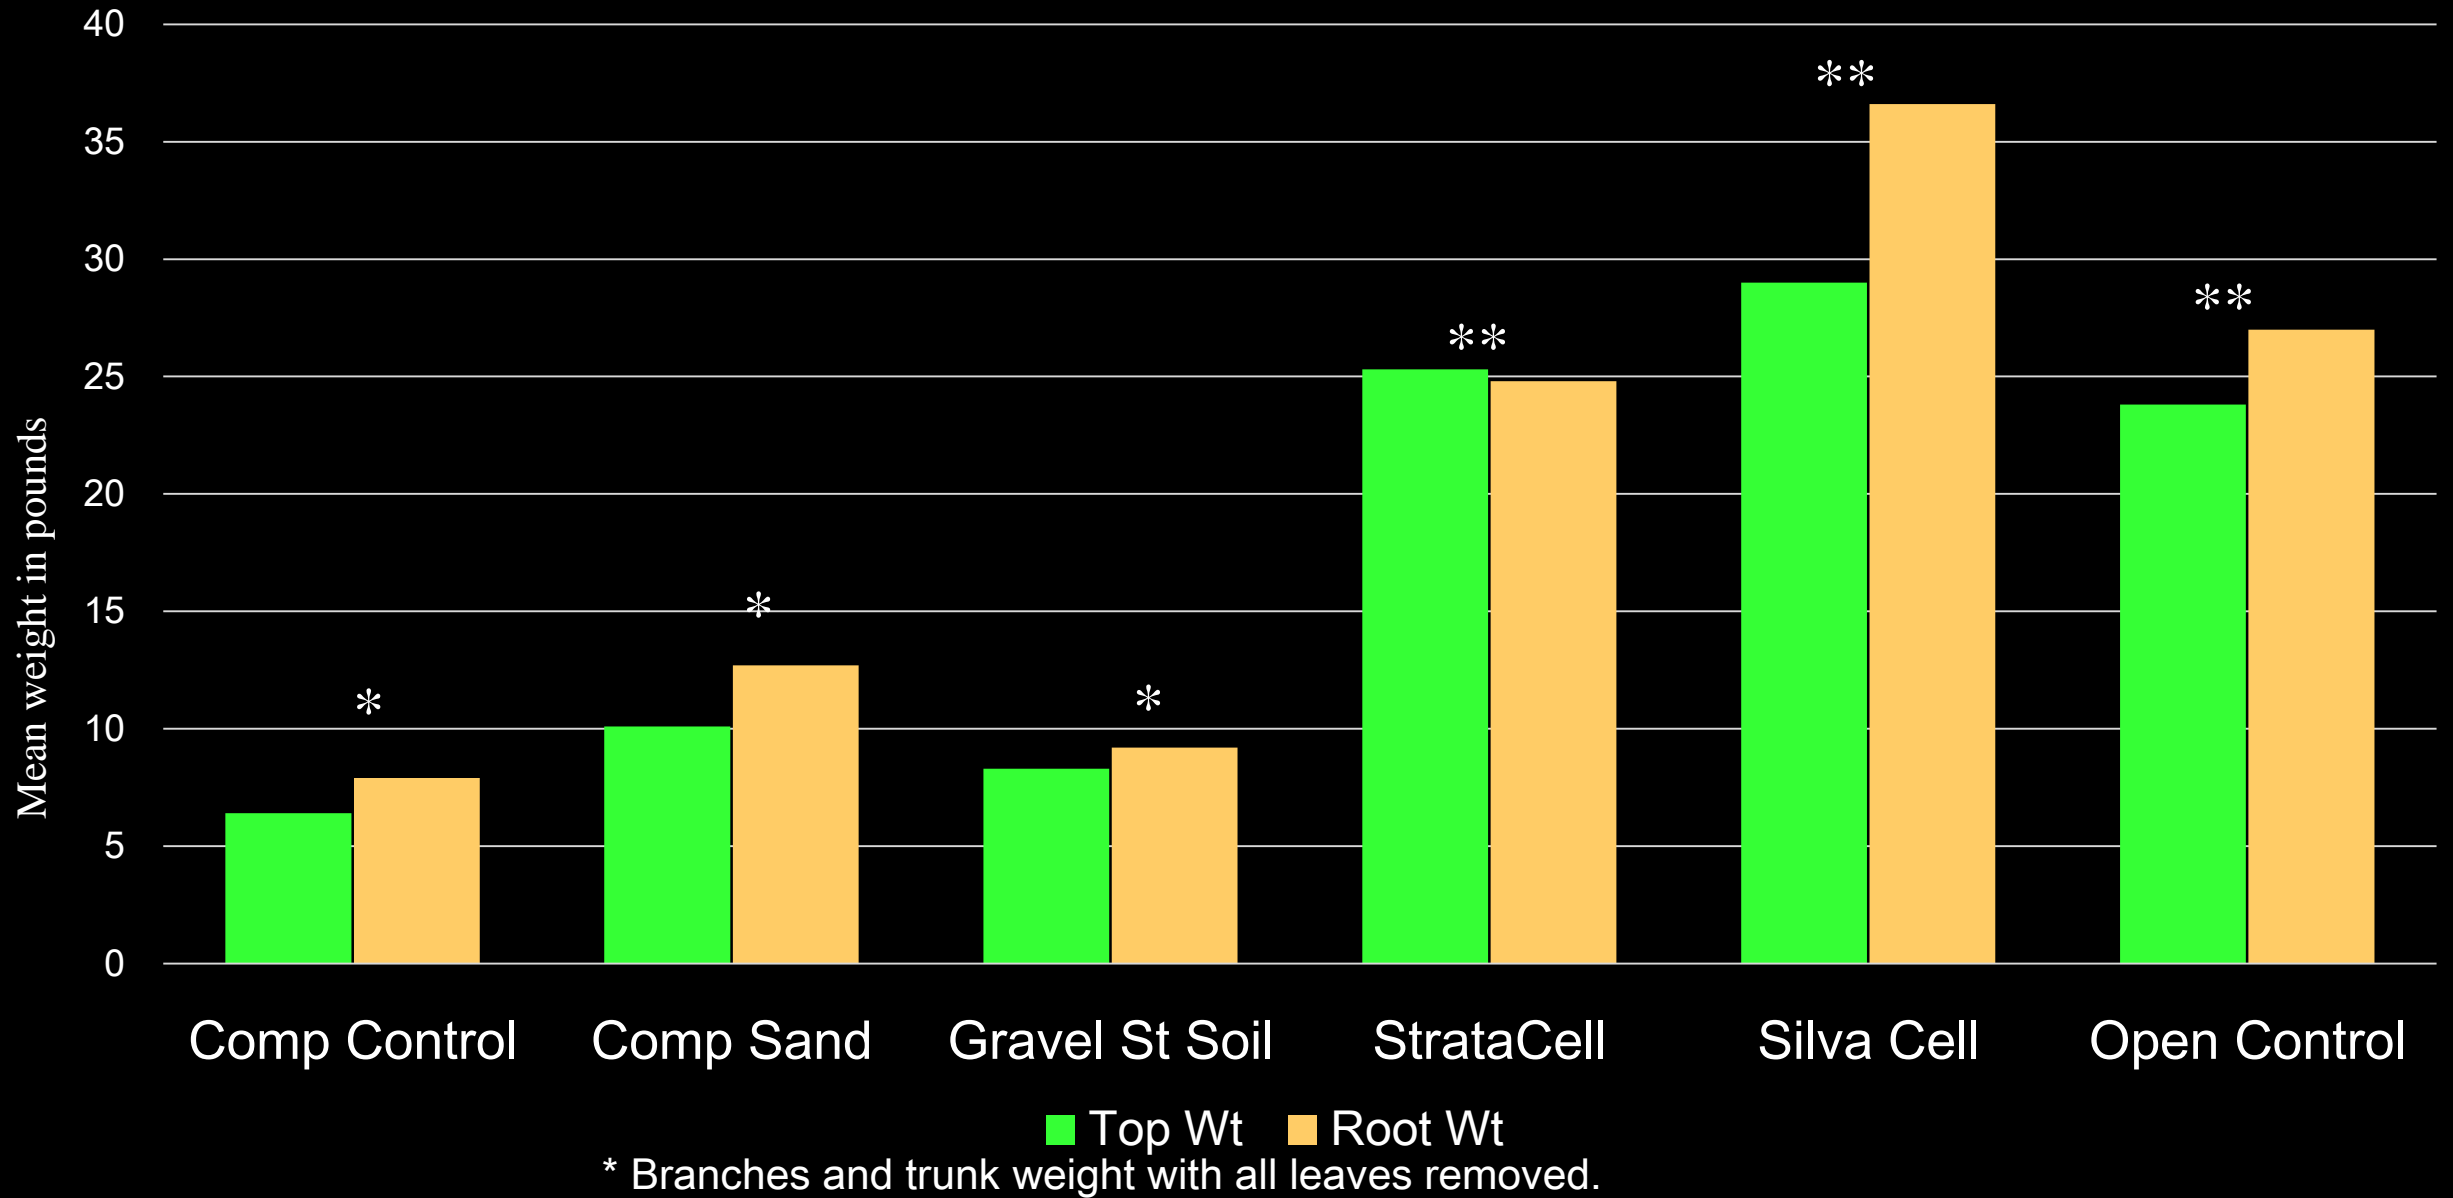
Weight of the Tops* and Roots

Which Weighs More, the tops or roots?

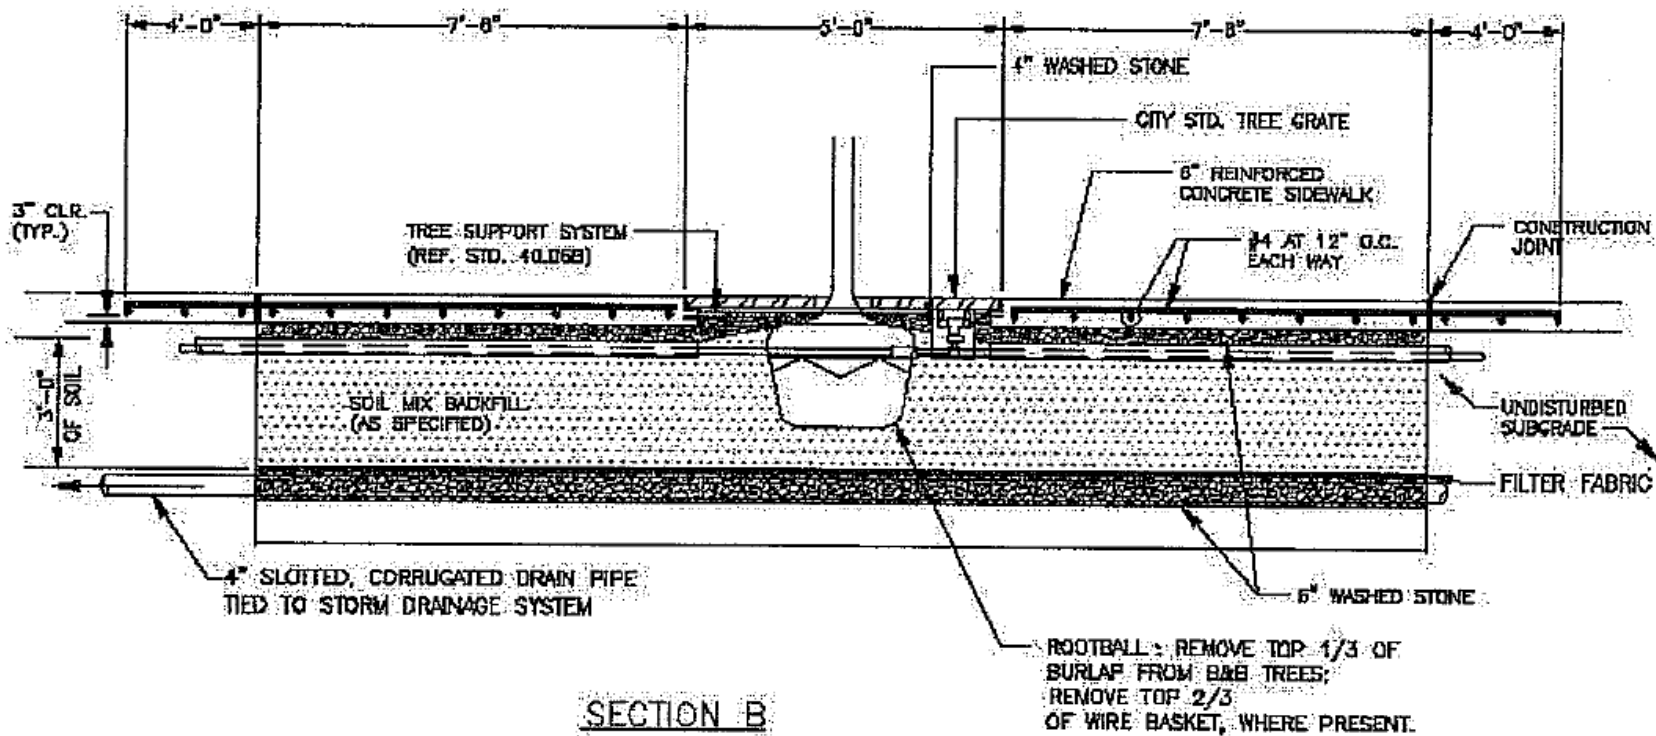
40.03B	REV.

SECTION B

**TREE PIT WITH
GRATE IN SIDEWALK (SECTION)**

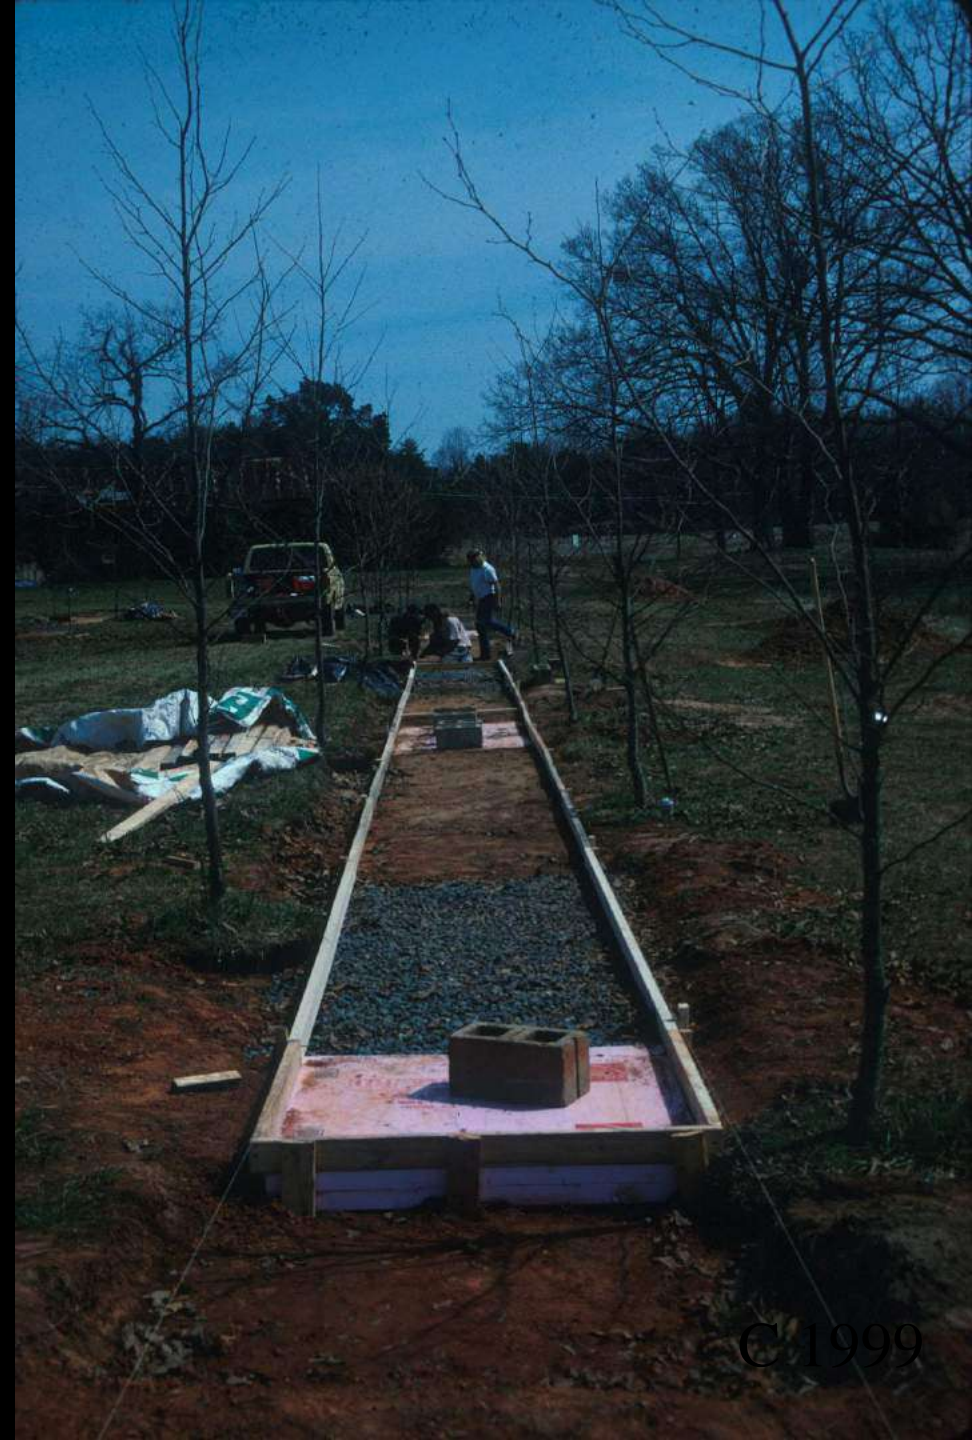
Established
1996
Suburban
sidewalk
design and
construction
London
Planes

Deep Root Barrier

Black Poly 450mm 18"

Styrofoam 100mm 4"

Gravel 100mm 4"

Soil/Gravel Mix 100mm

Control

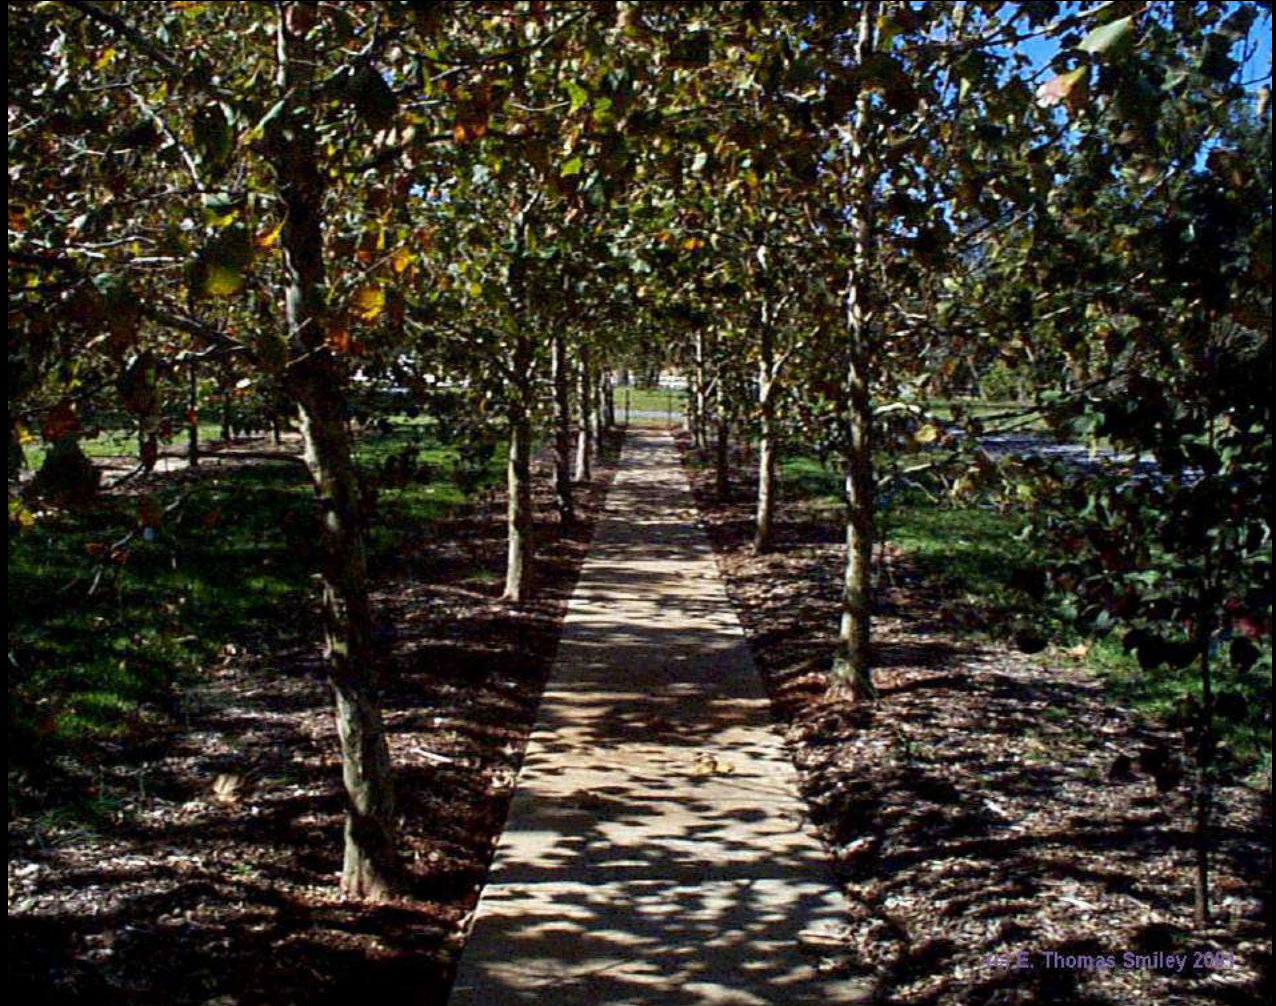
Sidewalk Plot

Sidewalk
lifting
appears in
2000

Four years
after
installation

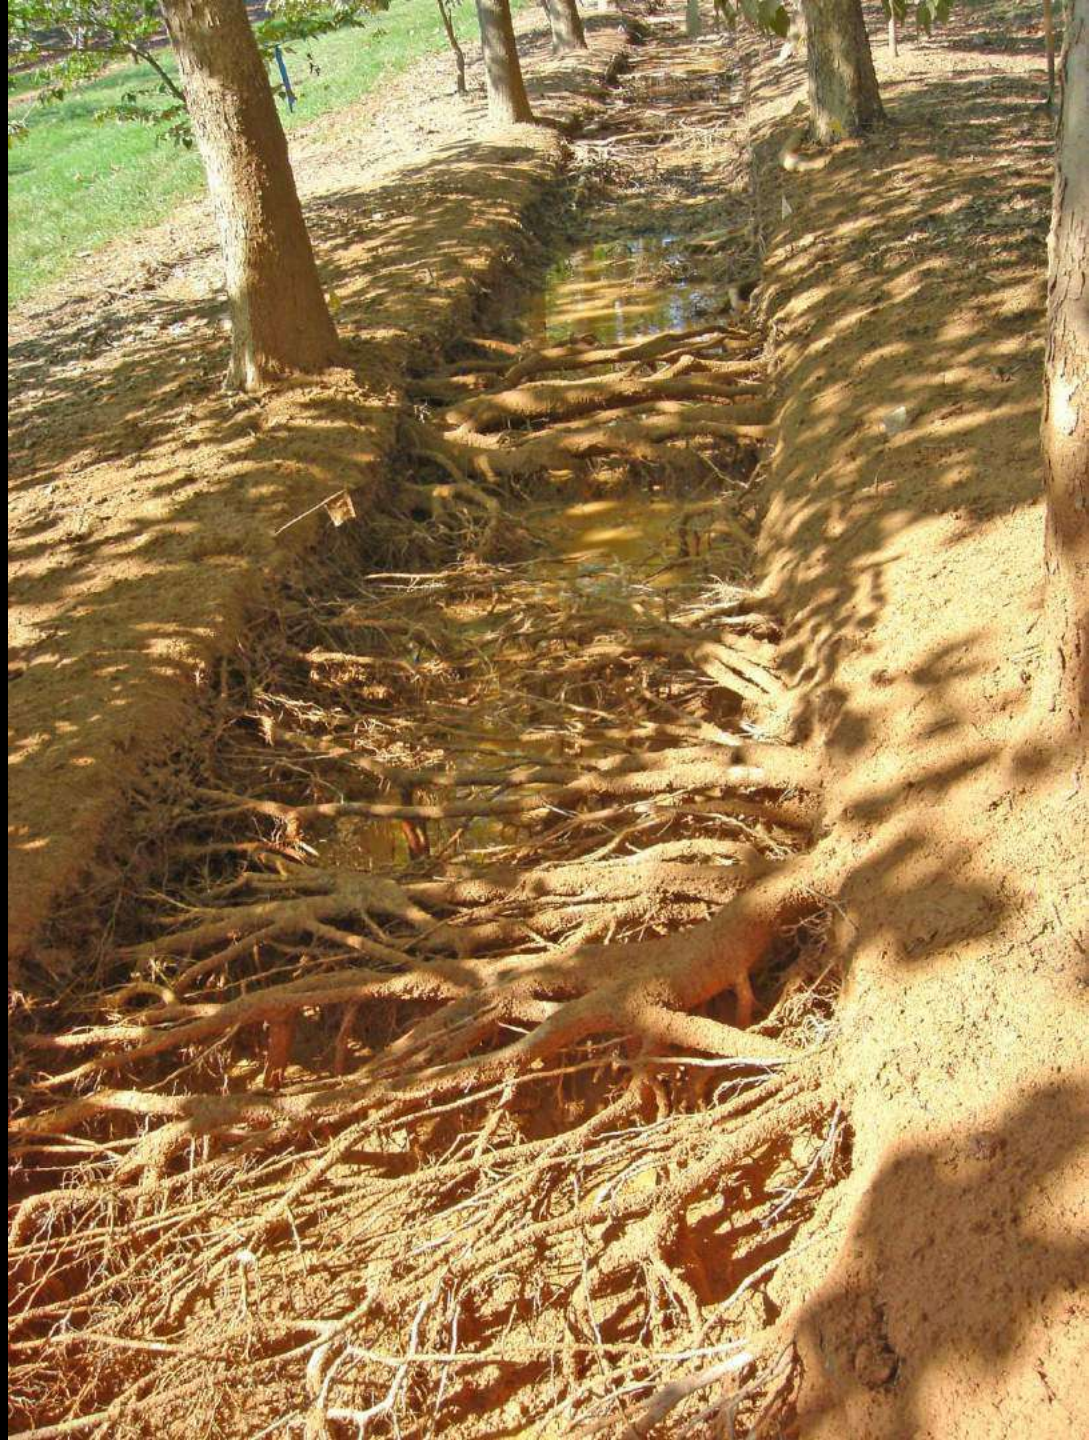
Gravel Soil Mix

One of the Worst Treatments for sidewalk lifting – Need more than 4"

Control next to Gravel Soil Mix

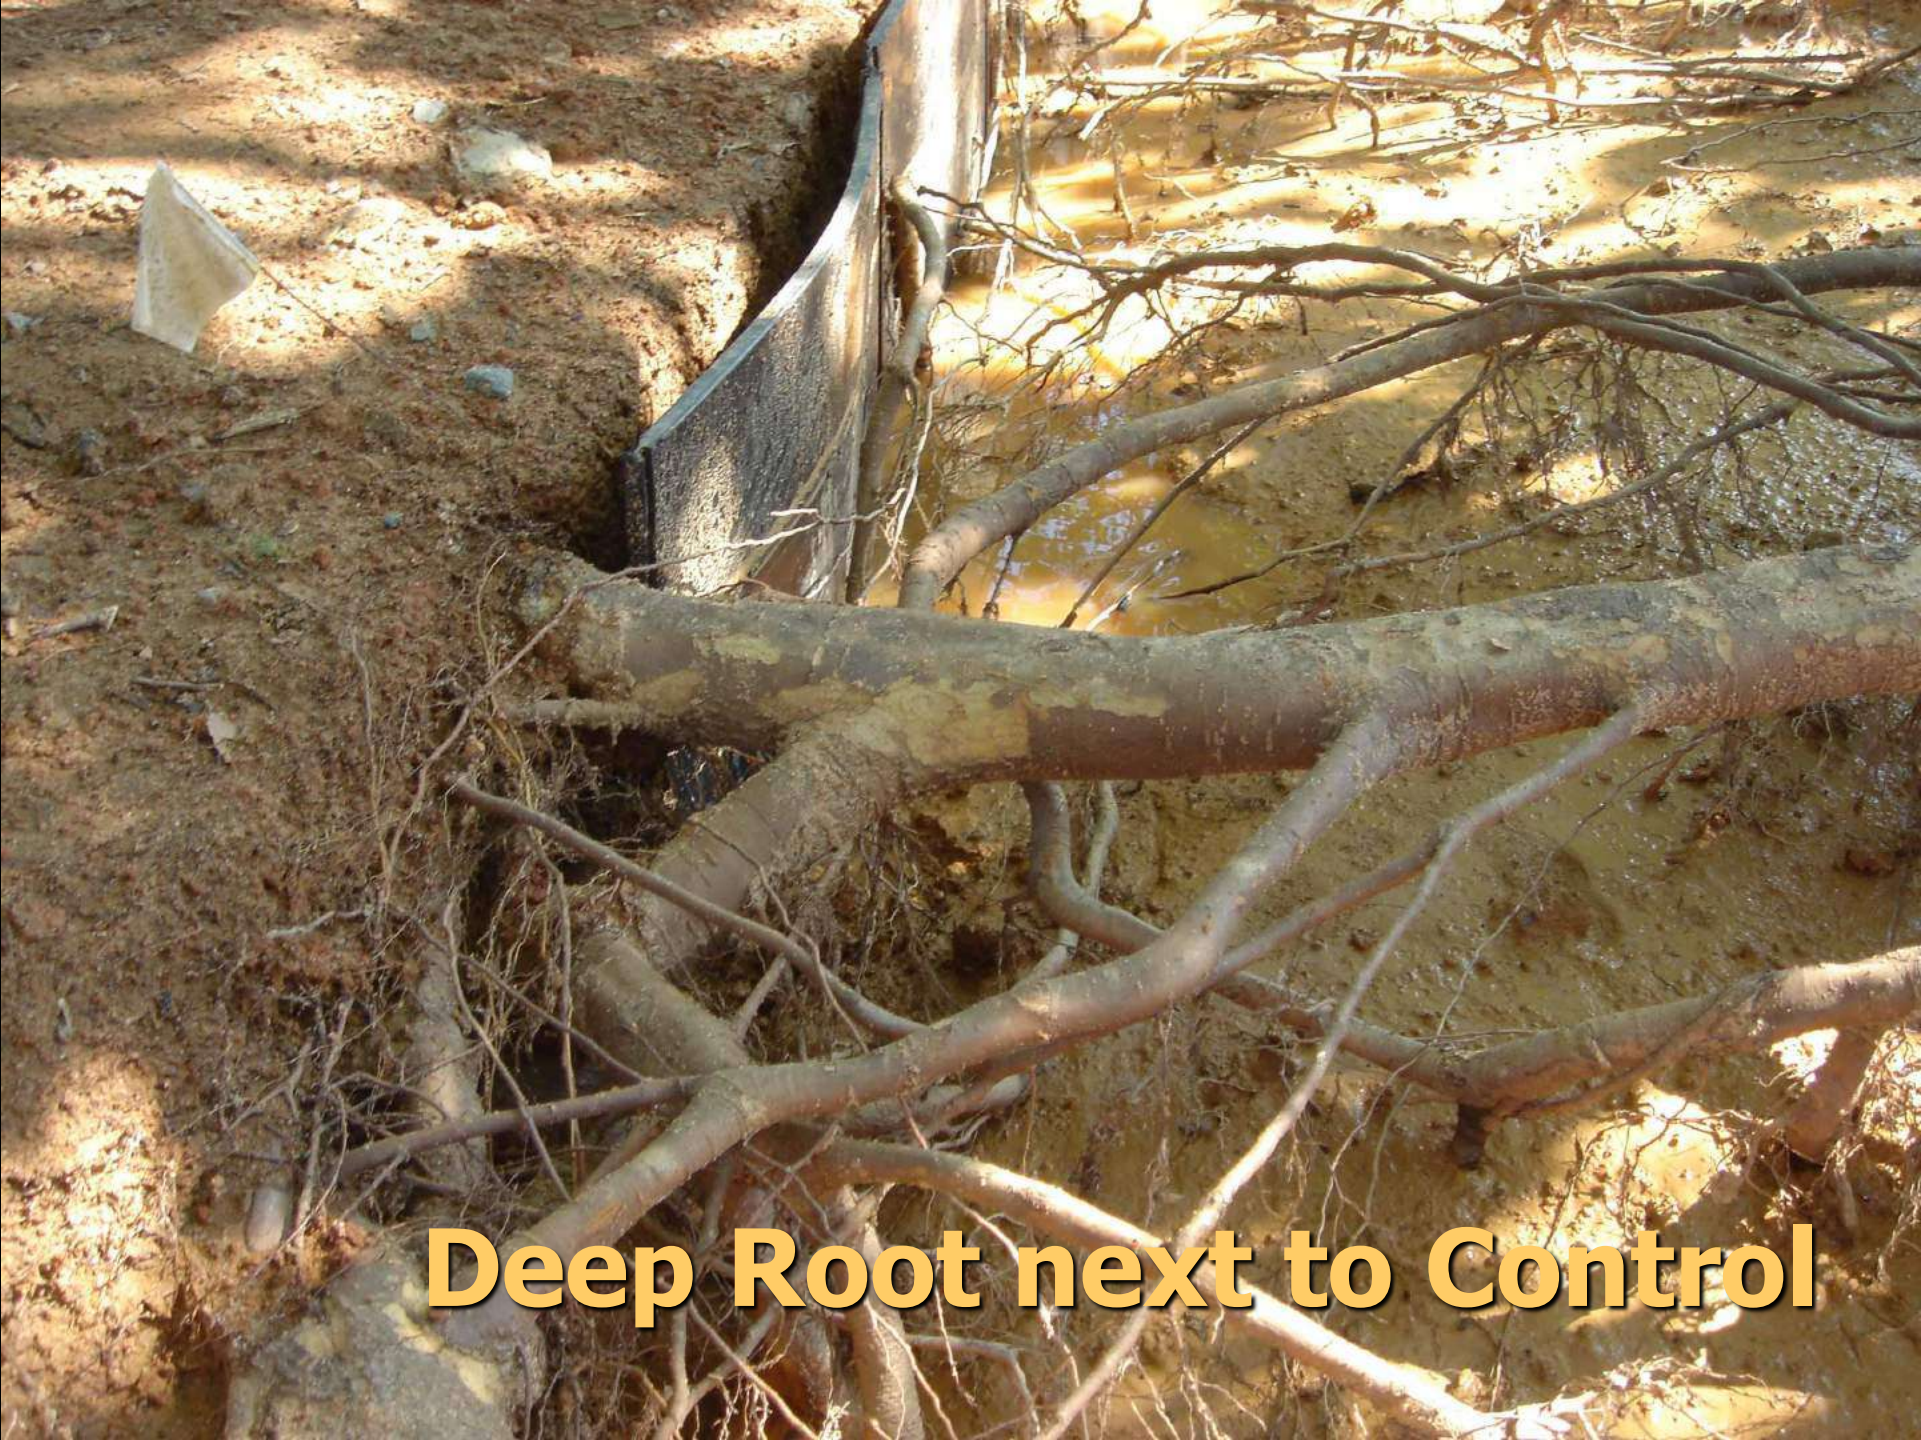
Deep Root Barrier

One of the Best Treatments

Deep Root next to Control

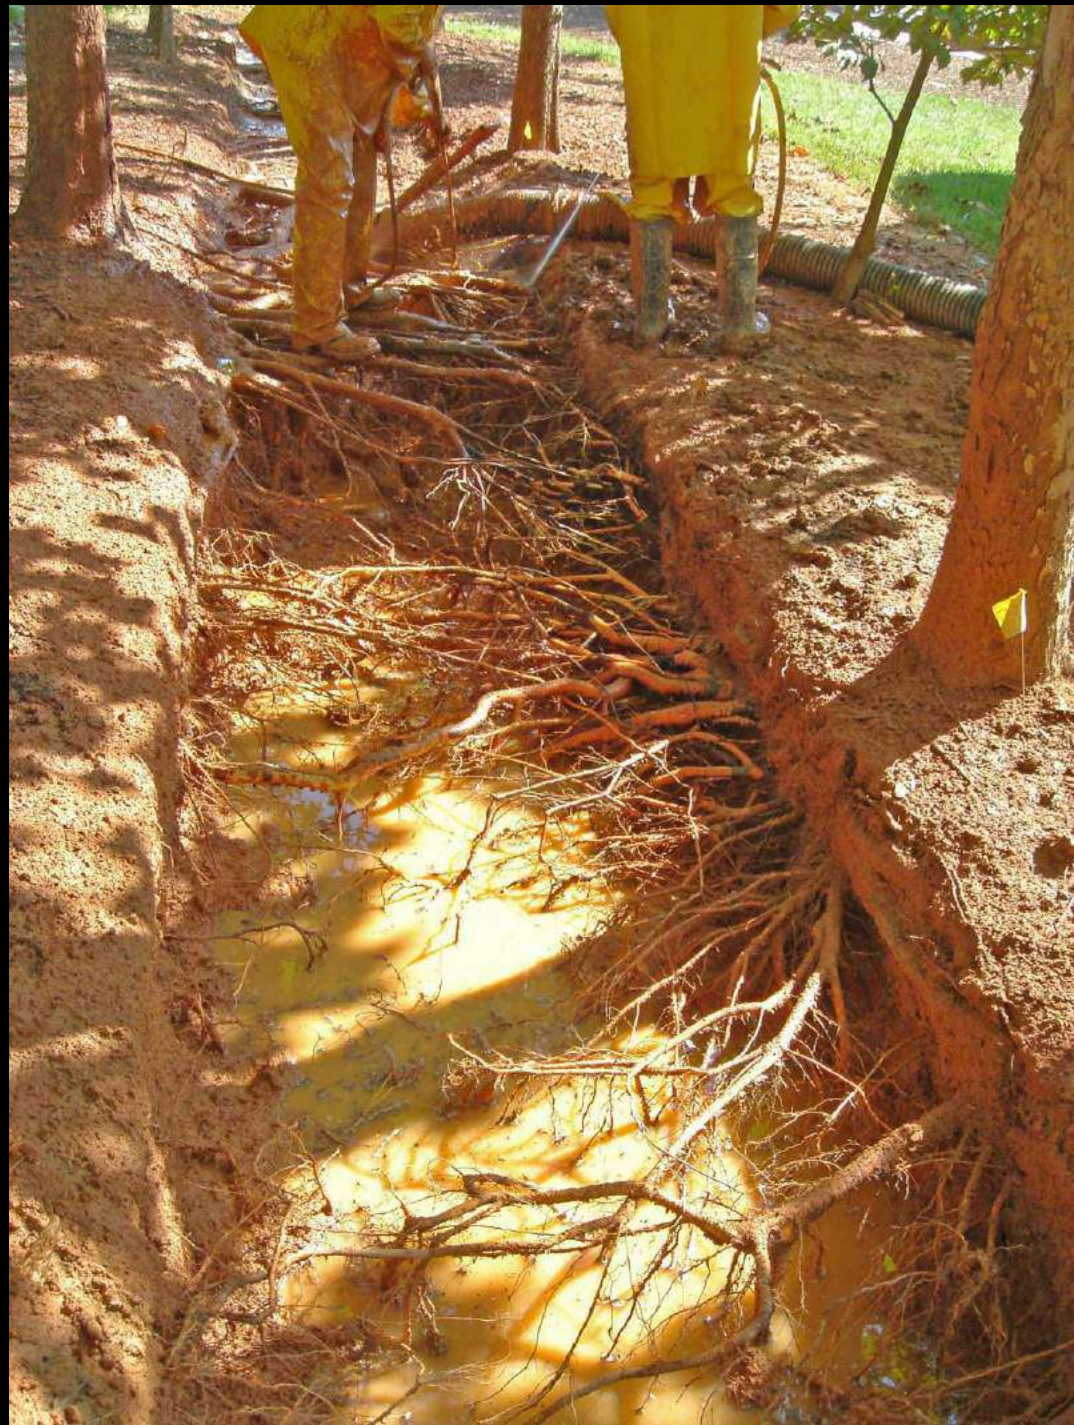
**Gravel (25-40mm, 1-1.5",
washed)**

One of the Best Treatments
Fewer, smaller and deeper roots

**Best treatments for
reducing lifting and root
growth under pavement
Reducing Sidewalk
Lifting**
